## Protect the Butternut 30-Meter Doorknob Capacitor Phil Salas – AD5X

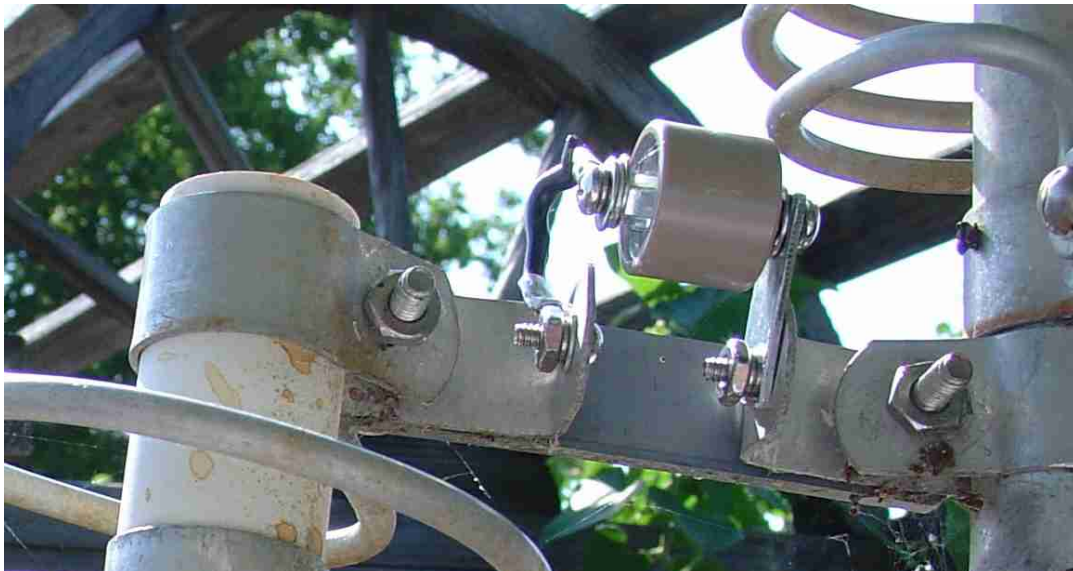
My Butternut HF-6 has served me very well for the past 20 years. The only problem I've had is that the 67 pf doorknob capacitor on the 30-meter coil has failed three times (most recently just a few months ago). This problem is characterized by loss of sensitivity and high SWR on 20- and 30-meters meters – usually intermittently at first, which makes it difficult and frustrating to determine where the problem is . I believe this problem is due to stresses placed on the capacitor when the antenna sways in the wind. If you examine the way in which this doorknob capacitor is mounted compared to the other doorknob capacitors, you can see why this could occur (the capacitor is mounted with aluminum brackets to a possibly flexible piece of dielectric material) . To resolve this problem, I cut out a small 1" x 1/2" x 0.037" aluminum bracket (aluminum sheet available from ACE Hardware). I drilled 1/8" holes on either end of this bracket, and mounted the 67 pf capacitor to one side of the existing bracket on the 30 meter coil using a #4 screw, lockwasher and nut. Next, I made up a 1" piece of wire with #4 solder lugs on each end and used this to connect the other end of the capacitor to the 30 meter mounting bracket, again with #4 hardware. This wire eliminates any potential stress on this capacitor. The photo shows the details.
