KX3 Internal Speaker "buzz" Fix Phil Salas – AD5X

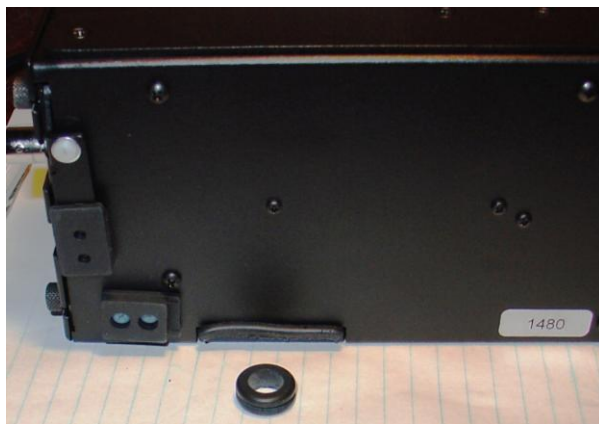
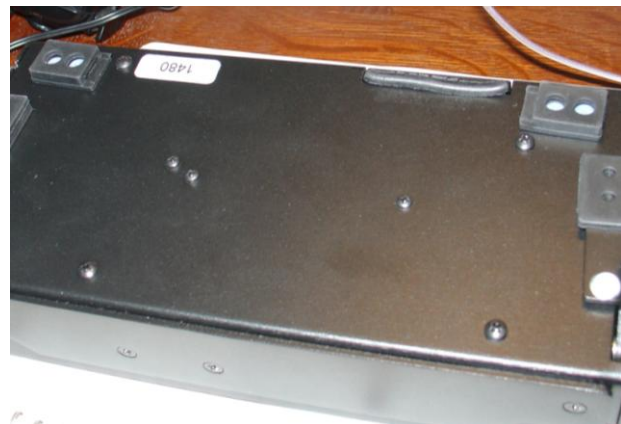
I love my Elecraft KX3, but I had a speaker buzz in the 400-800Hz range at low-to-moderate volume levels (15-20) that was so bad that it made using the internal speaker completely unusable for CW. It appears that the case itself has a natural resonance in this frequency range, and the speaker mounting bracket acts as a resonator that couples energy into the case. The biggest improvement occurred when Elecraft sent me a new speaker as the original speaker cone was offset and was just touching the grill. However, I could still get the buzz at higher volume levels (>25). I improved this by putting layers of black electrical tape between the bottom of the speaker bracket and the bottom case - i.e. I inhibited the mounting bracket vibration some with layers of tape. But I've never been happy with the tape.

For my final "fix" I took a 0.375"ID 0.625"OD rubber grommet (Mouser part number 534-745), snipped it, unfolded it, and installed it between the speaker bracket and bottom cover. This completely eliminated the buzz, except at maximum audio level (where the buzz is only just apparent). Photos 1 & 2 illustrate this better than words. This works great, and I'm a happy camper now! The only issue would be the hassle of keeping track of the snipped grommet were I replacing internal batteries frequently, but I use external power.
